# ASSESSMENT OF DAM SAFETY OF COAL COMBUSTION SURFACE IMPOUNDMENTS

**Gulf Power  
Plant Scholz  
Sneads, Florida**

Prepared for  
*U.S. Environmental  
Protection Agency  
Washington, D.C.*

October 2012

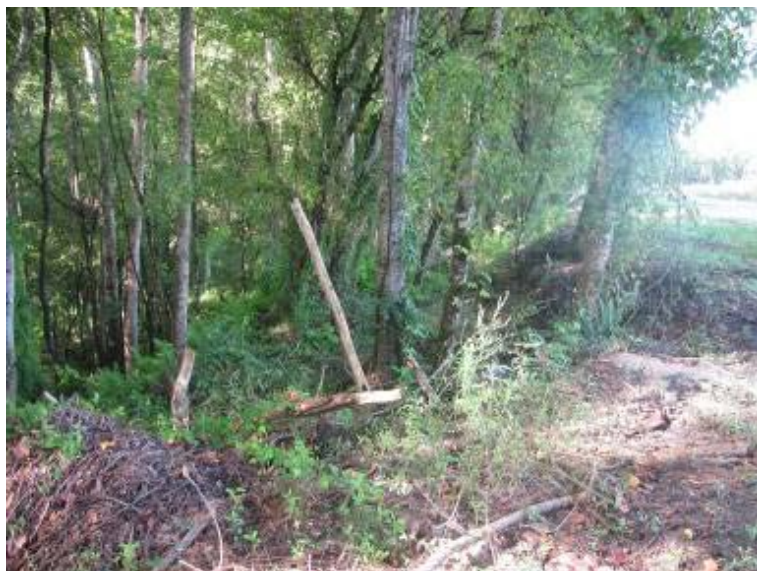
Photo 1: Lower Pond – Southeast embankment exterior slope, looking southwest. Note trees and dense vegetation.

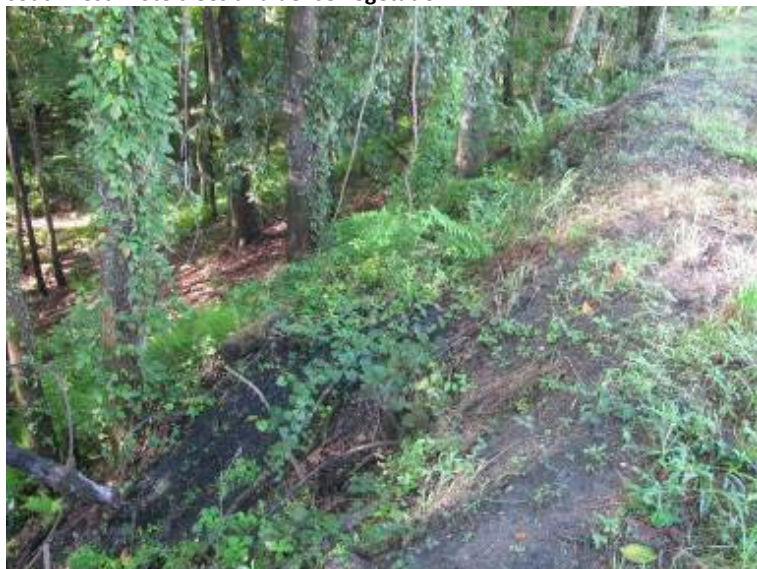
Photo 3: Lower Pond – Southeast embankment exterior slope, looking southwest. Note erosion of crest and trees/dense vegetation on exterior slope.

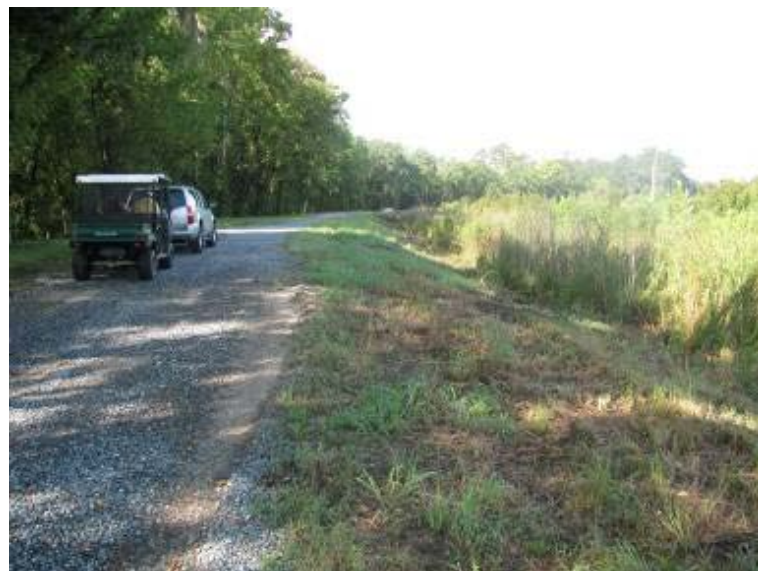
The crest appeared to be in good condition (Photographs 2 and 6). The average crest width is approximately 30 feet. The crest widens to approximately 40 feet near the south corner near the NPDES discharge area and a chemical storage building (Photograph 8). Crests are gravel-covered without vegetation (Photos 2, 5, 6 and 26). No depressions or evidence of settlement were observed on the crest. Ruts and tire tracks were observed on the northwest divider embankment (Photograph 28).

Photo 2: Lower Pond – Southeast embankment interior slope, looking southwest.

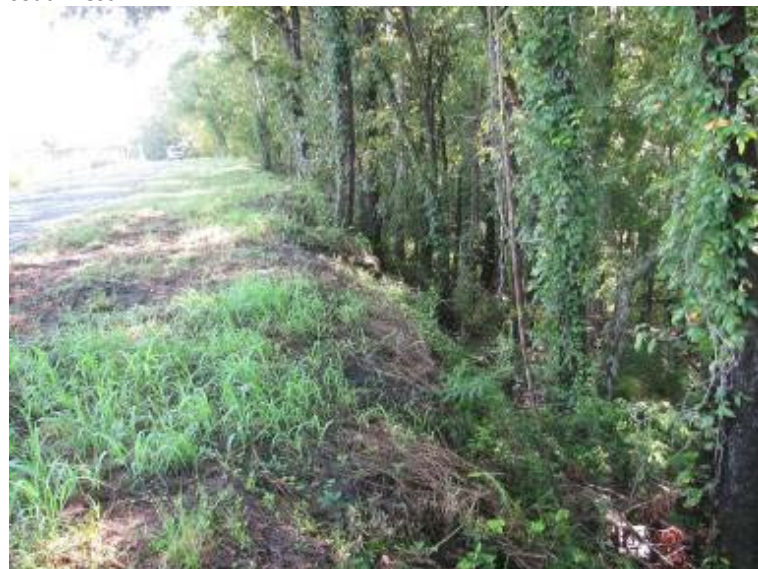
Photo 4: Lower Pond – Southeast embankment exterior slope, looking east. Note steepness, eroded areas along crest, trees, and dense vegetation.

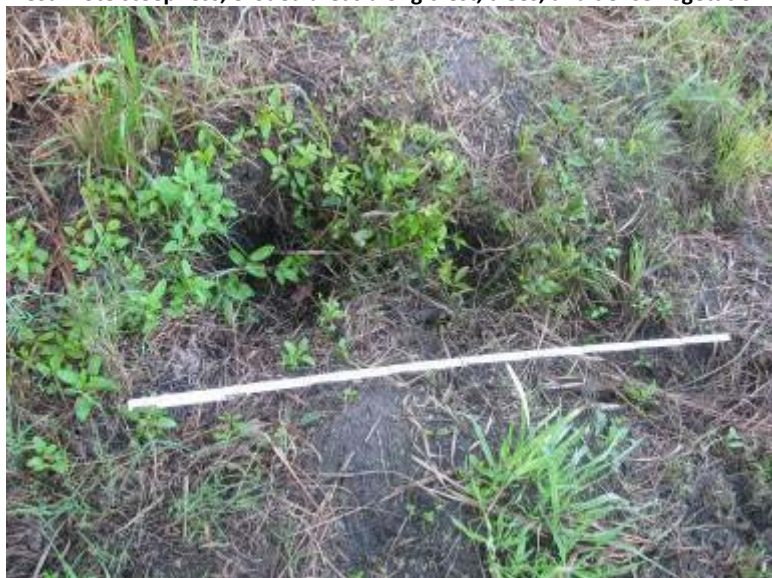
Photo 7: Lower Pond – Southeast embankment interior slope, 5-foot long by 1-foot wide by 16-inches deep scarp, looking southeast.

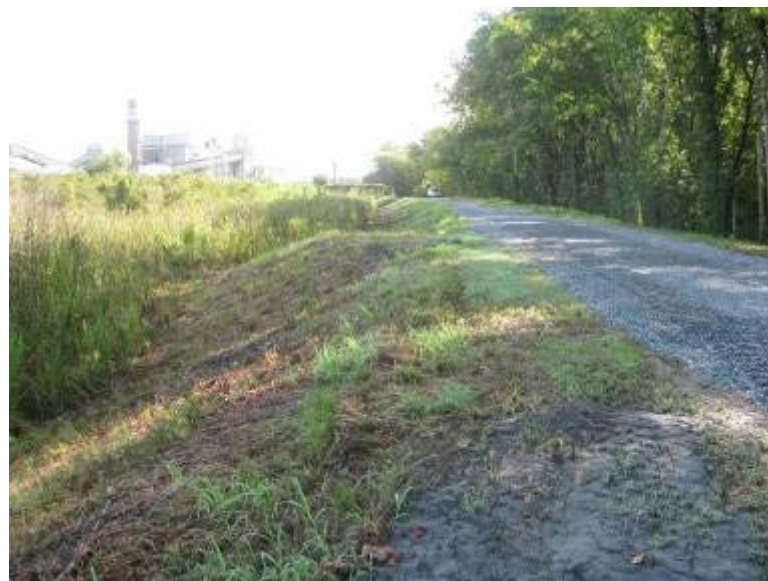
Photo 6: Lower Pond – Southeast embankment interior slope, looking northeast.

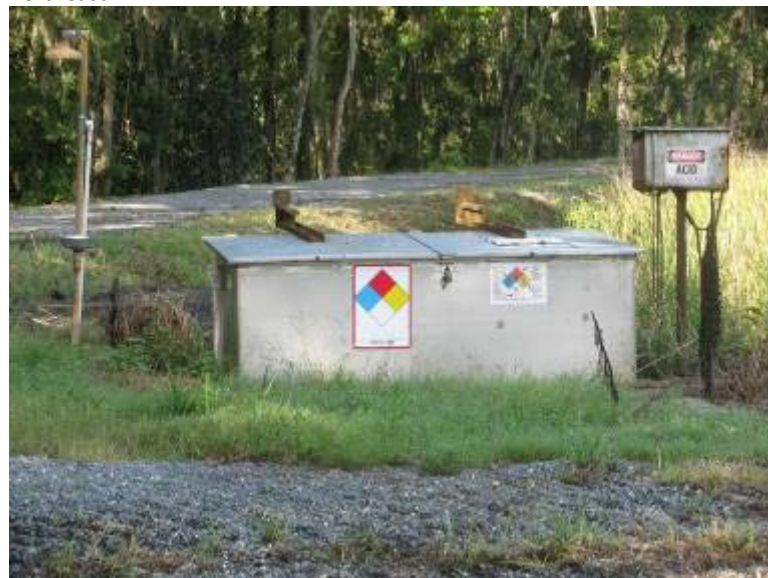
Photo 8: Lower Pond – Southeast embankment exterior slope, chemical storage system looking west.

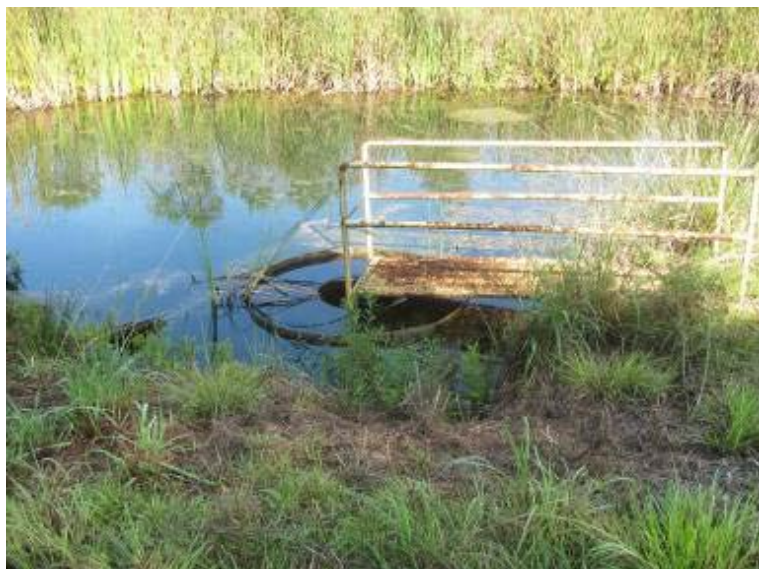
Photo 9: Lower Pond – Southeast embankment interior slope, Morning glory-type drop inlet structure. Pipe is metal, 24-inches in diameter with a trash rack.

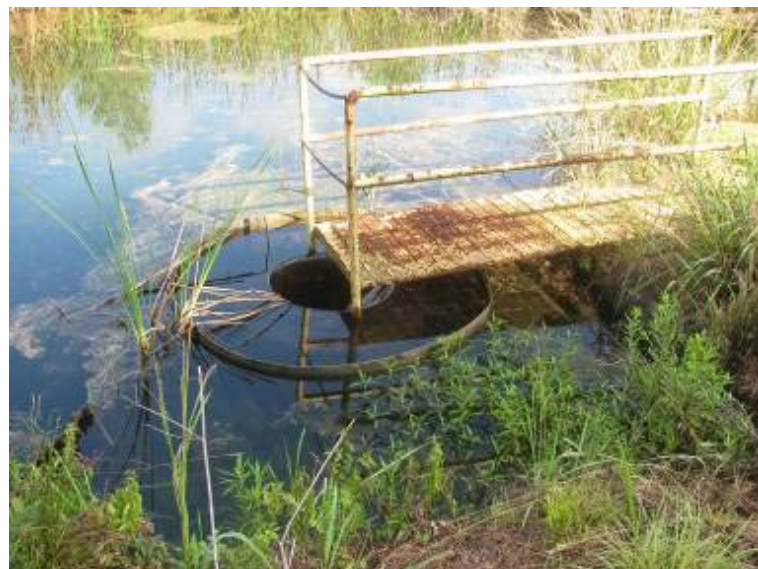
Photo 10: Lower Pond – Southeast embankment interior slope, Morning glory-type drop inlet structure. Pipe is metal, 24-inches in diameter with a trash rack.

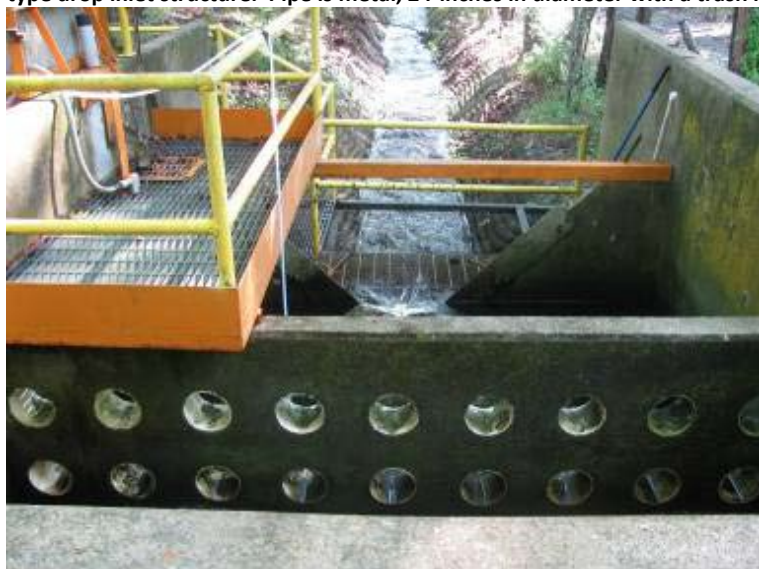
Photo 11: Lower Pond – Outside southeast embankment exterior slope, outlet structure looking northeast. Outflow to lined ditch is through V-notch weir.

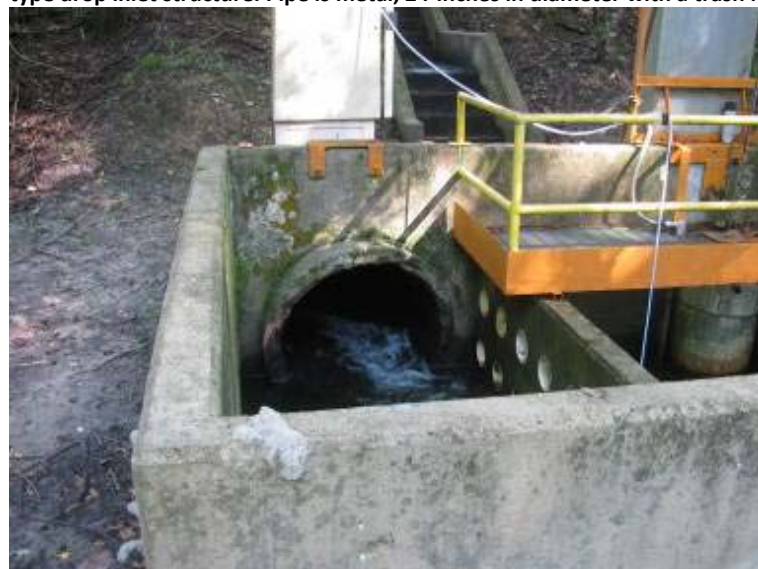
Photo 12: Lower Pond – Outside southeast embankment exterior slope, outlet structure looking northwest. Outlet from pond is via 27-inch diameter Reinforced Concrete Pipe (RCP).

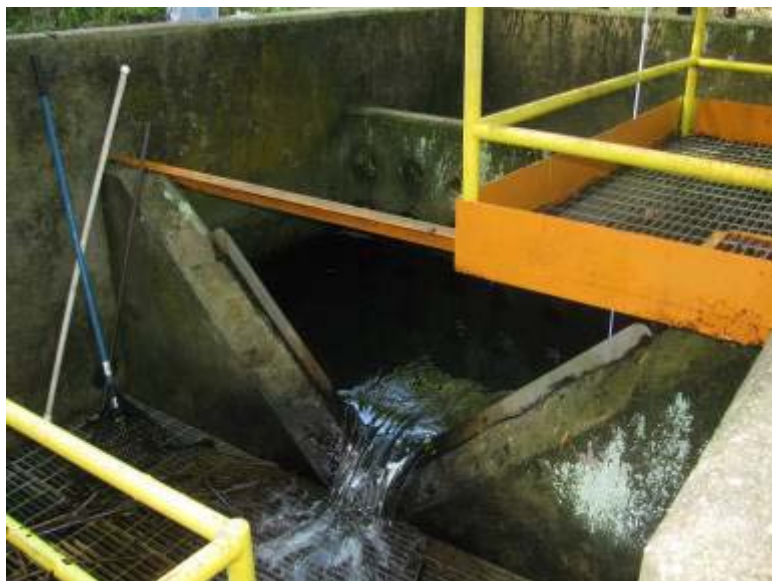
Photo 13: Lower Pond – Outside south embankment exterior slope, outlet structure located at toe of exterior slope, looking southwest.

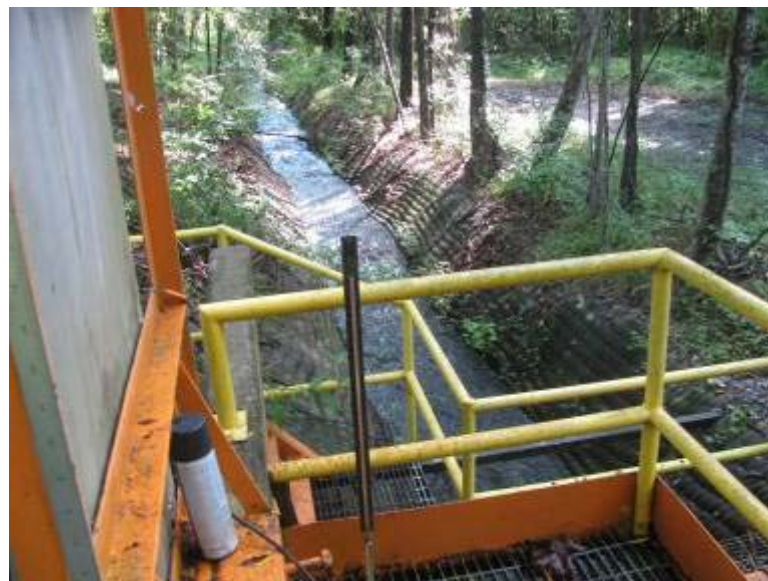
Photo 14: Lower Pond – Outside south embankment exterior slope, outlet structure with discharge from pond area flowing through lined ditch.

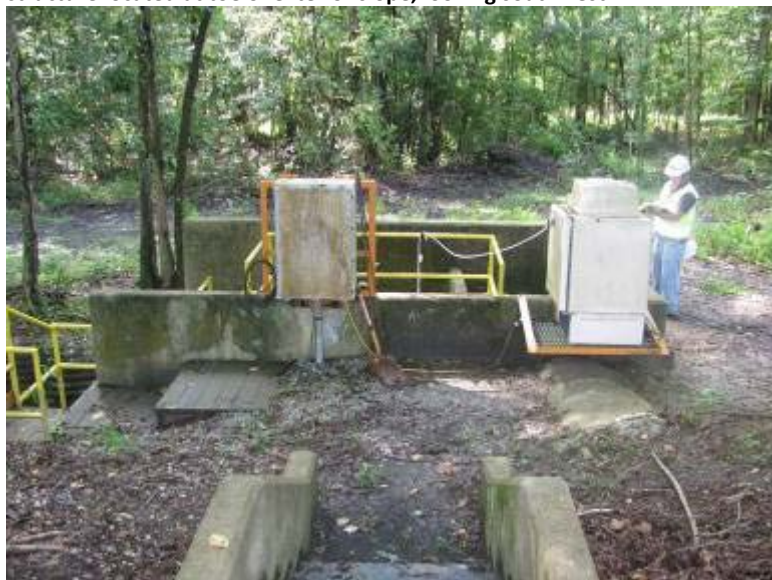
Photo 15: Lower Pond – Outside Southeast embankment exterior slope, general view of outlet structure and flow-meter, looking southeast.

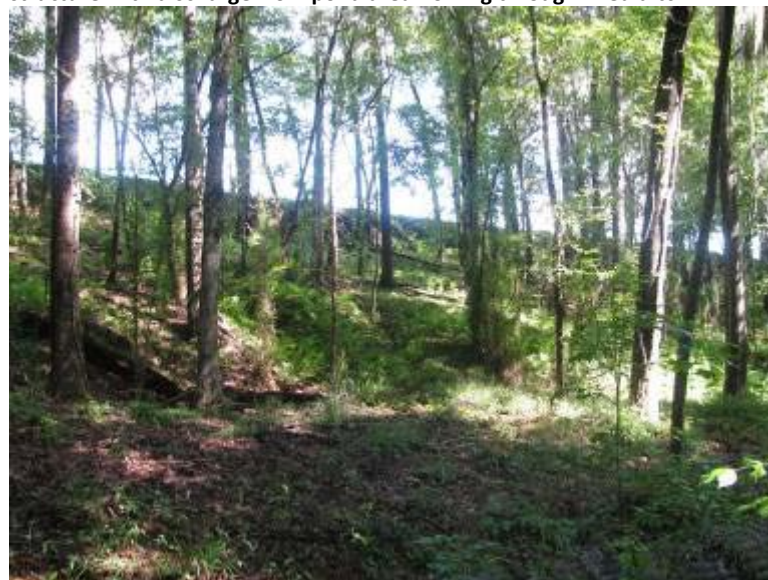
Photo 16: Lower Pond – Southeast embankment exterior slope, looking north From toe. Note steepness, trees, and dense vegetation.

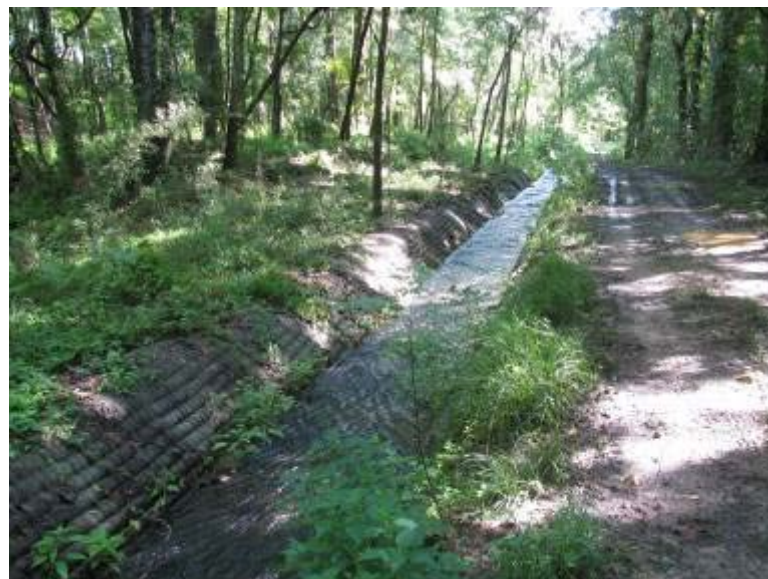
Photo 18: Lower Pond – Outside southeast embankment exterior slope Fabri-Form installation discharge channel located in wooded area beyond toe of exterior slope looking east.

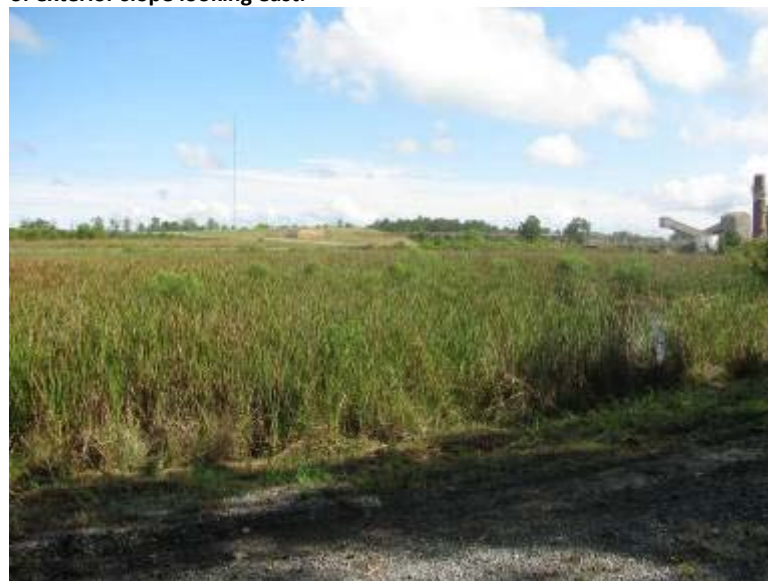
The Lower Pond is located adjacent to and south of the Middle Pond, sharing a common divider embankment with the Middle Pond. The Lower Pond contained standing water during the assessment, with approximately 6 ½ feet of freeboard and an embankment height of about 30 feet on the south and southeast sides. The north and northwest embankment height is about 6 feet. The pond receives water from the Middle Pond near the north corner of the pond. Pond surface is densely vegetated with cattail (Photograph 20).

Photo 20: Lower Pond – Southeast embankment interior slope, looking north.

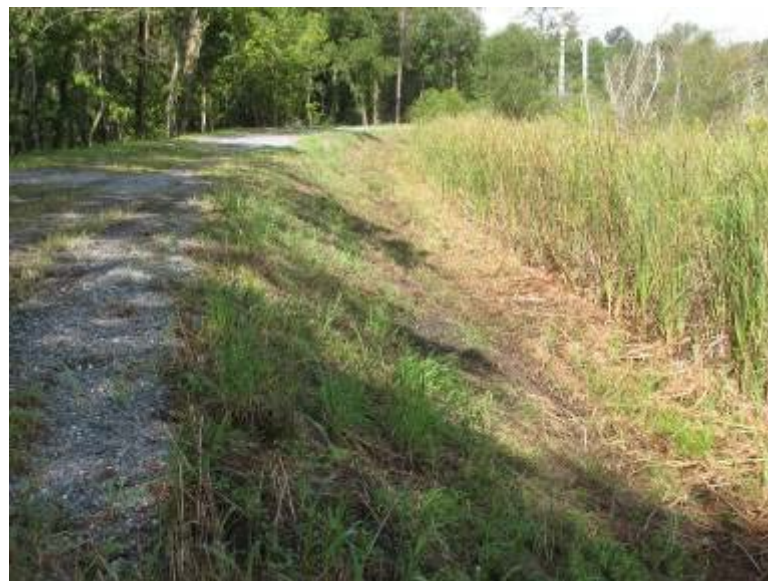
Photo 22: Lower Pond – South embankment interior slope, looking west.

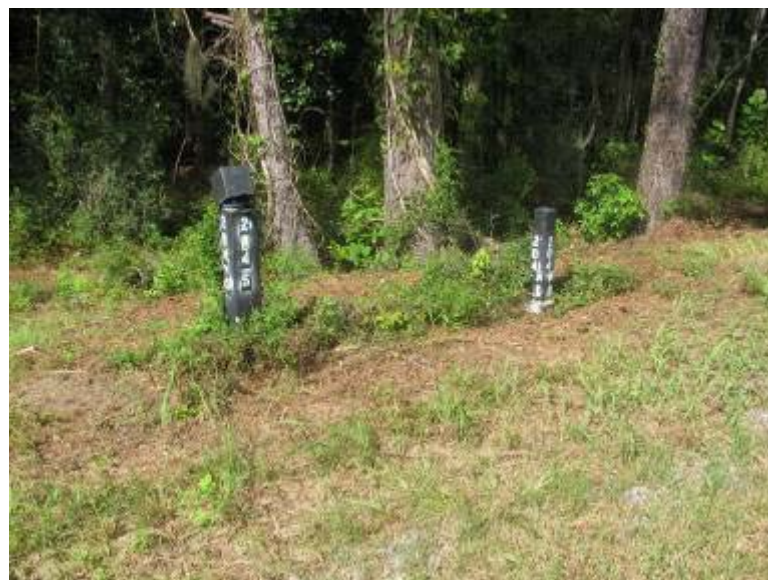
Photo 24: Lower Pond – Southwest embankment exterior slope, groundwater monitoring wells looking west.

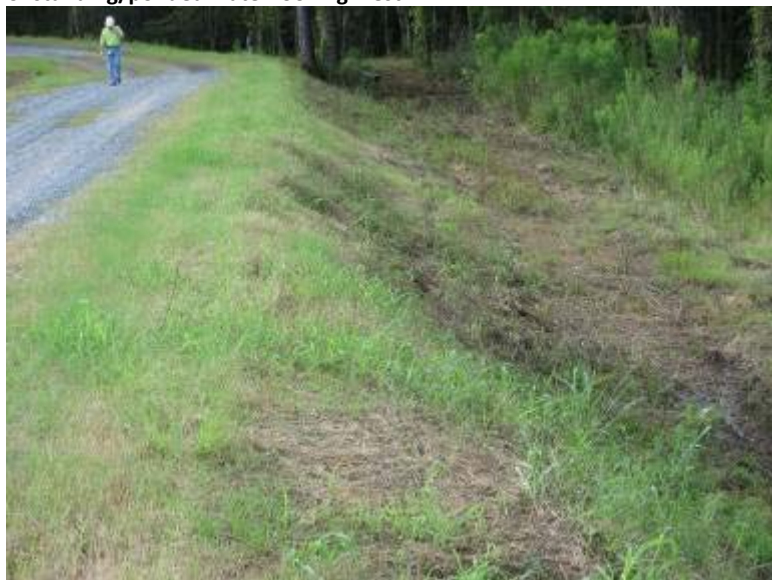
Photo 27: Lower Pond – Southwest embankment exterior slope looking southeast.

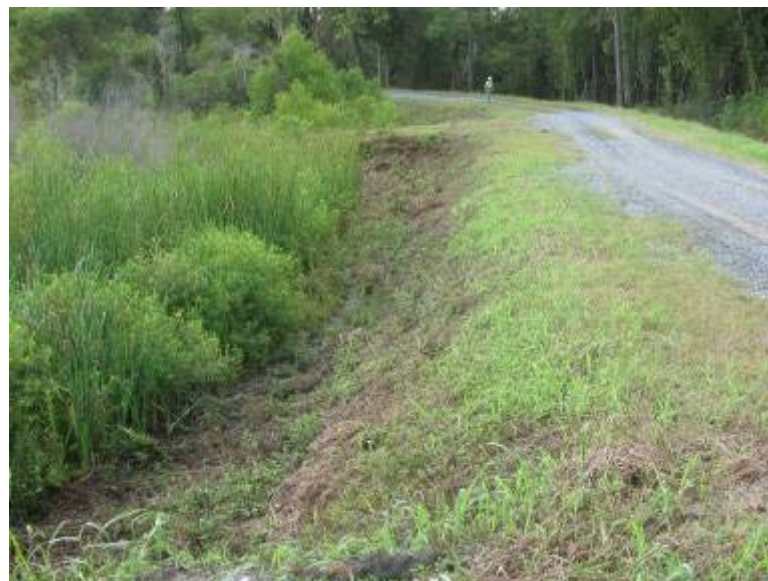
Photo 26: Lower Pond – Southwest embankment interior slope, looking southeast.

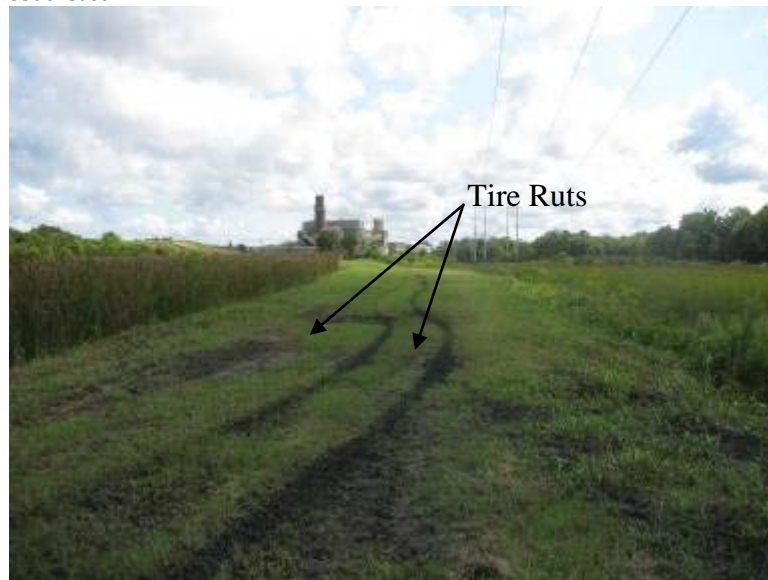
The crest of the Middle Pond appeared to be in good condition (Photographs 115 and 116). The average crest width is approximately 25 feet. The southwest and west crests are gravel-covered with sparse short grass. The crest of the divider embankment between the Middle Pond and the Lower Pond appeared to be in good condition. The crest of the west embankment of the pond is nearly level with the natural ground elevation west of the pond area. The north and southeast divider embankments seem to be constructed of soil and ash mix; no gravel was observed in this crest. No depressions or evidence of settlement were observed on the crests. Ruts and tire tracks were observed on the southeast divider embankment (Photographs 28, 109 and 110).

Photo 28: Lower and Middle pond – General view of crest of divider embankment looking northeast. Note tire ruts.

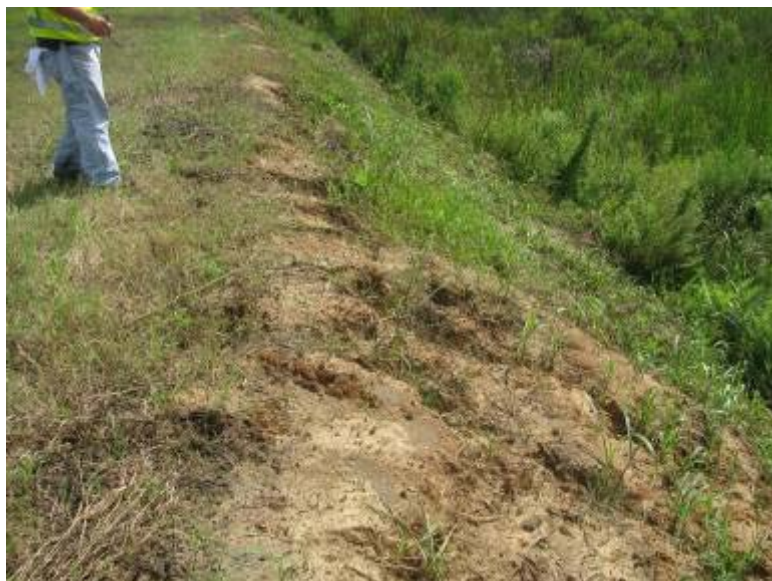
Photo 29: Lower pond – Divider embankment interior slope looking northeast.

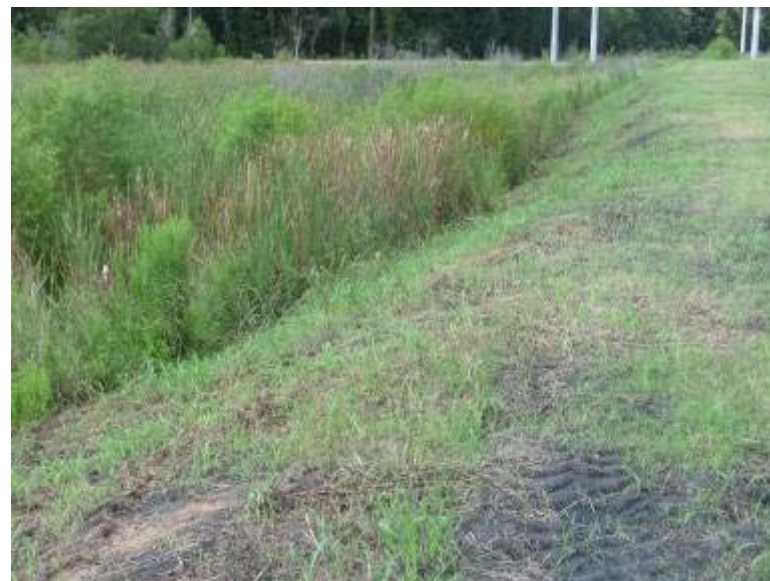
Photo 30: Lower pond – Divider embankment interior slope looking south.

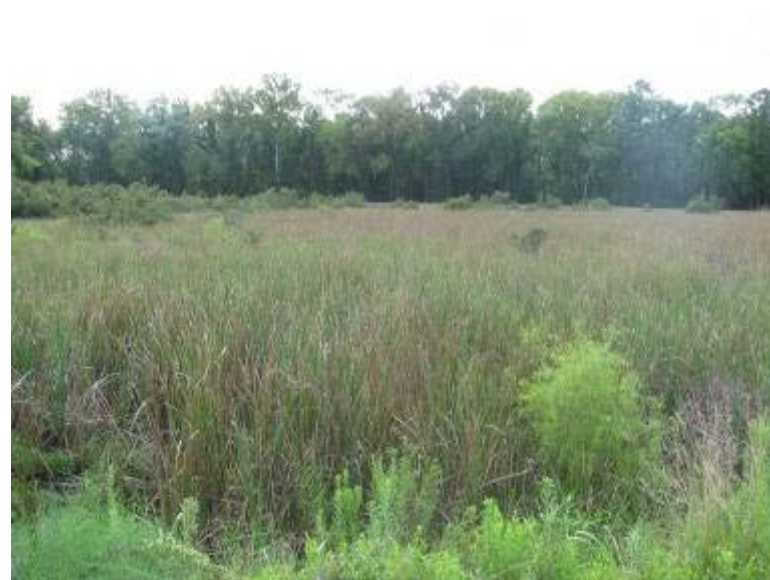
Photo 32: Lower pond – Divider embankment interior slope, general view of pond surface looking south. Note the vegetation (cattails).

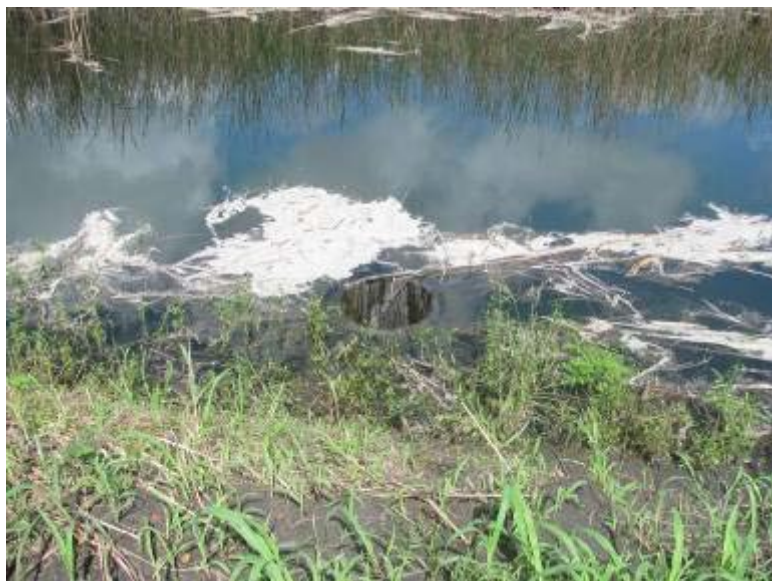
The Upper West Pond outlet structure consists of an 18-inch morning glory-type steel pipe located near the east corner of the pond (Photograph 33). The riser appeared to be free of debris and in good operating condition.

Photo 33: Middle Pond – Divider embankment interior slope, Morning glory-type drop inlet structure looking northwest. Pipe is 18-inch diameter metal.

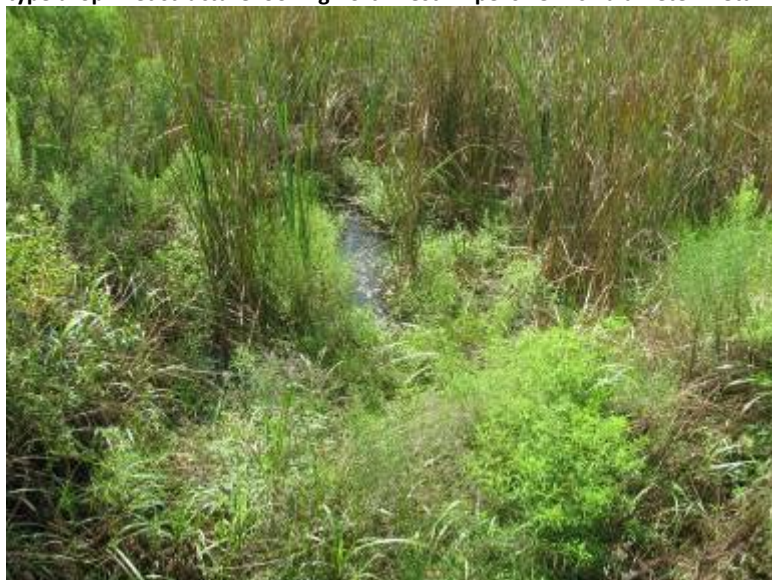
Photo 35: Lower Pond – Divider embankment interior slope looking south.

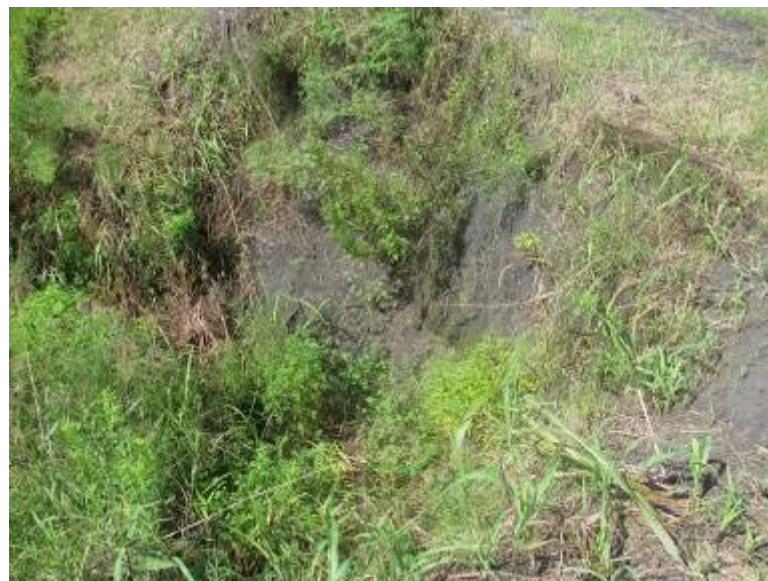
Photo 34: Lower Pond – Divider embankment interior slope looking south. Note scarp.

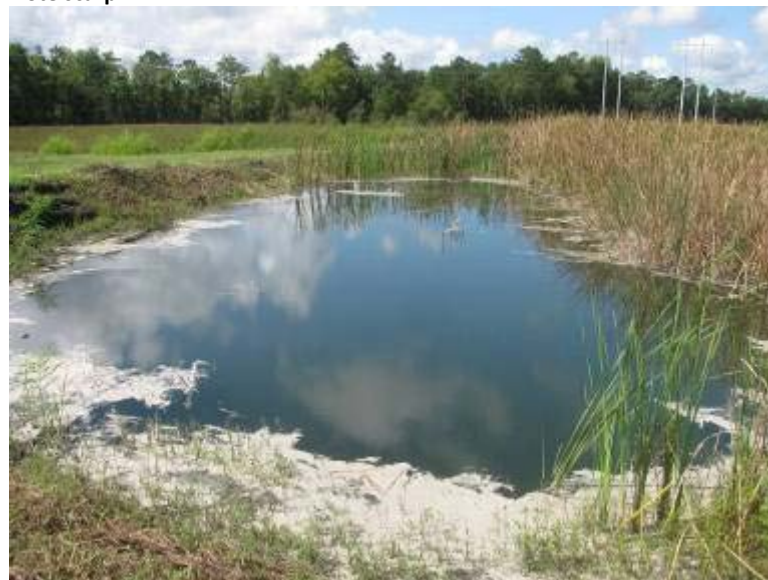
Photo 36: Middle Pond – General view of pond surface looking south.

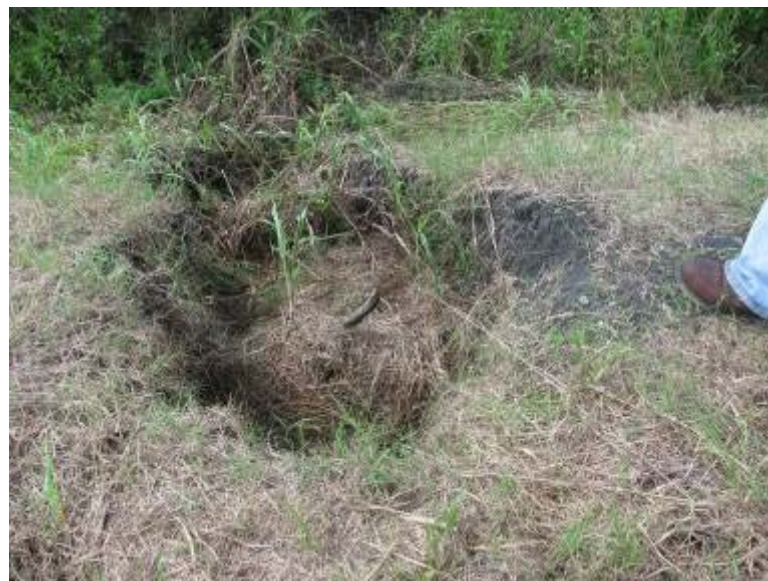
The interior slopes of the pond appear to be in poor condition. Significant surface erosion and scarps (Photographs 37, 38 and 40 to 42) were observed on the east corner and on the north and northwest embankments adjacent to the Ash Dry Stack. Due to the high vegetation and proximity to the Dry Ash Stack area, the slope was not accessible but appears from a distance to be very steep (Photographs 111 and 112). The Ash Dry Stack appears to cover the Middle Pond north divider embankment.

Photo 38: Middle Pond – North embankment interior slope, erosion rill looking south.

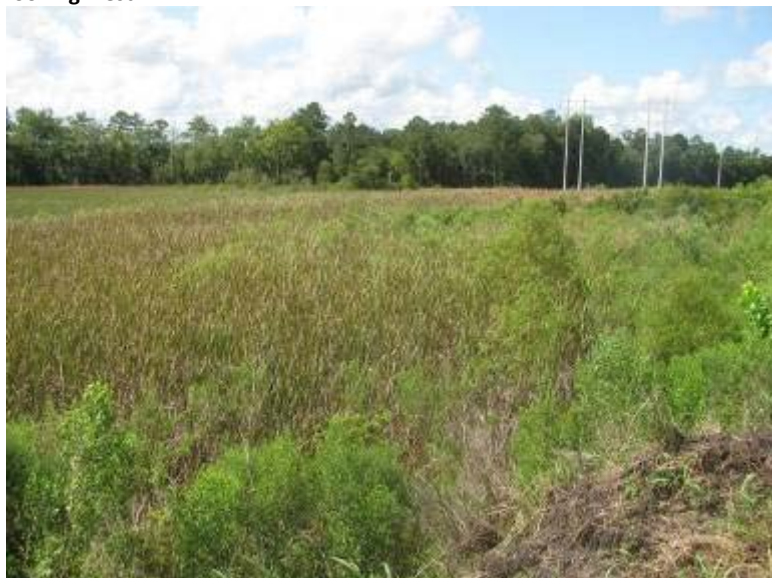
Photo 39: Middle Pond – North embankment interior slope, general view of pond surface looking southwest. Note vegetation (cattails).

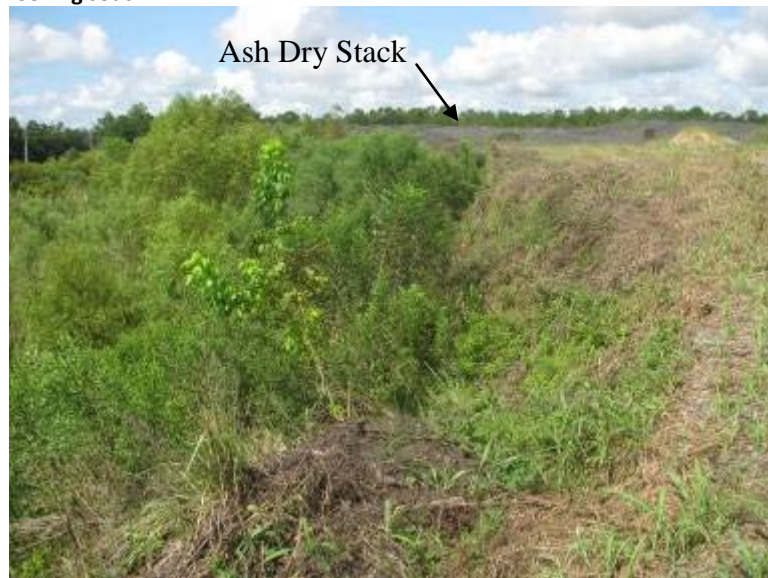
Photo 40: Middle Pond – North embankment interior slope, scarp looking west.

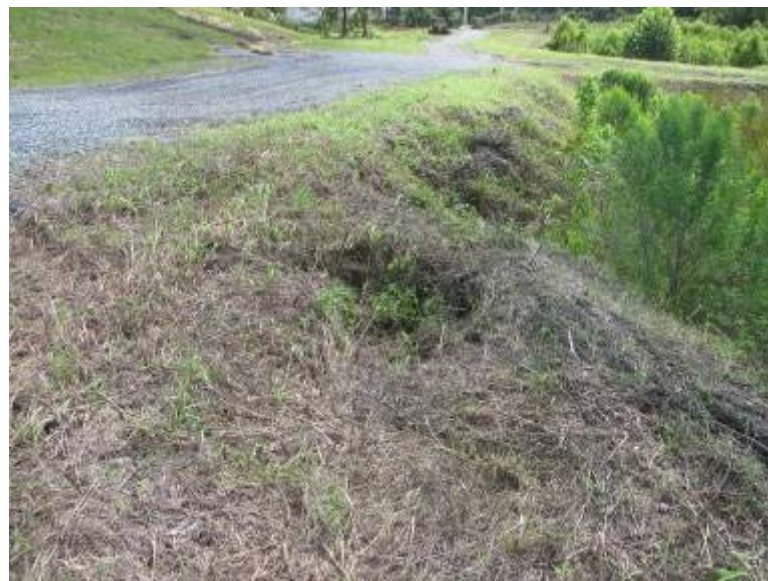
Photo 42: Middle Pond – North embankment interior slope, erosion looking east.

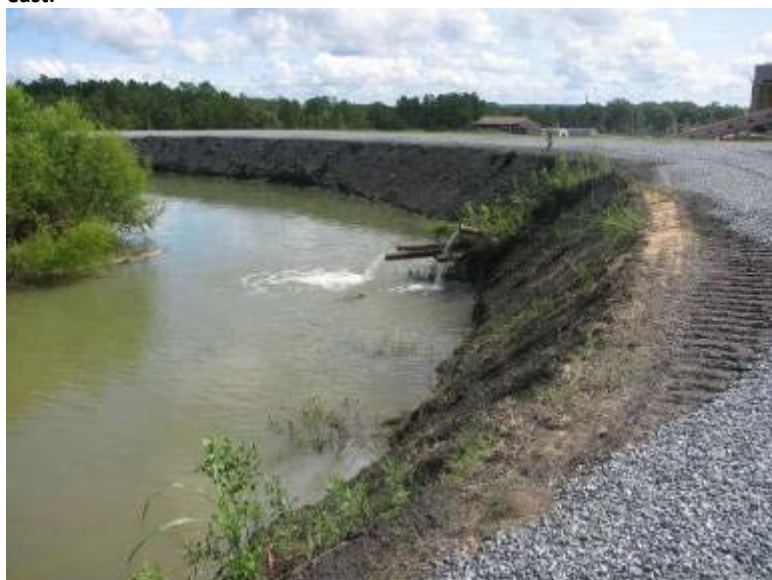
Inlet pipes are located at the south corner of the Upper East Pond (Photograph 43).

Photo 43: Upper East Pond –East embankment interior slope, general view of inflow pipes looking northeast.

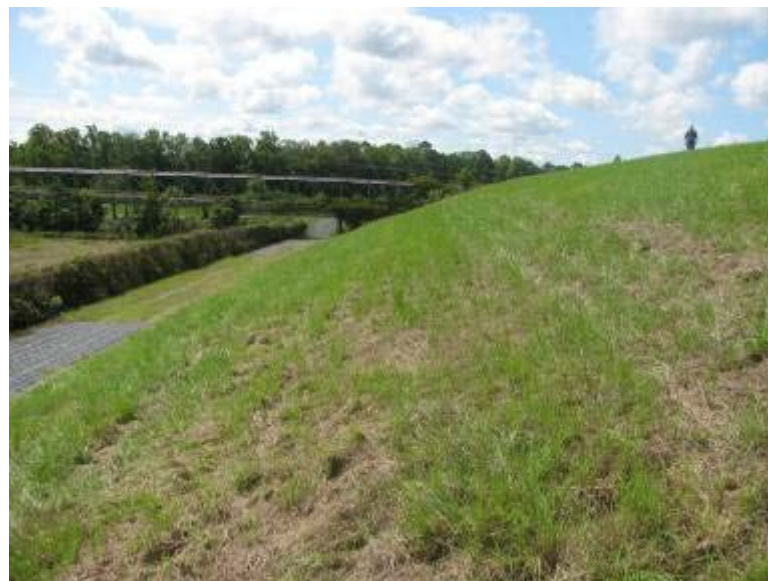
Photo 46: Upper East Pond – East embankment exterior slope, looking south.

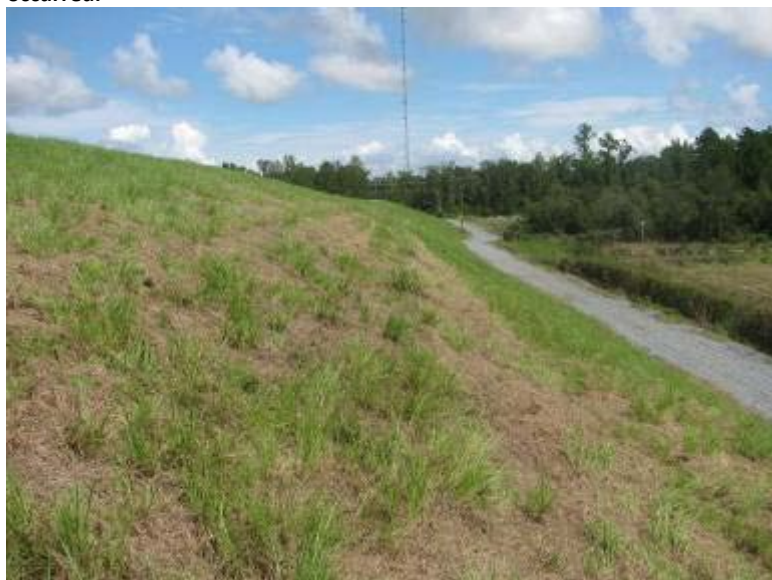
Photo 47: Upper East Pond – East embankment exterior slope, looking north.

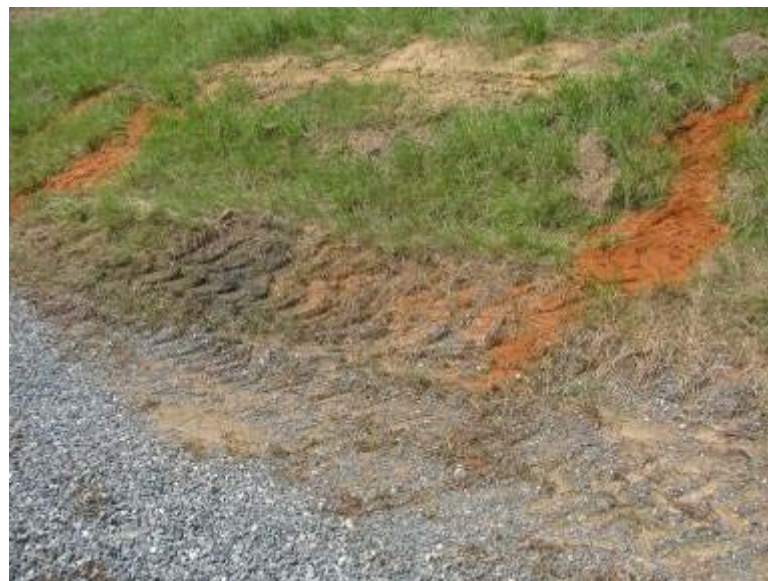
Photo 50: Upper East Pond – East embankment exterior toe of slope looking west. Note saturated area at toe of slope.

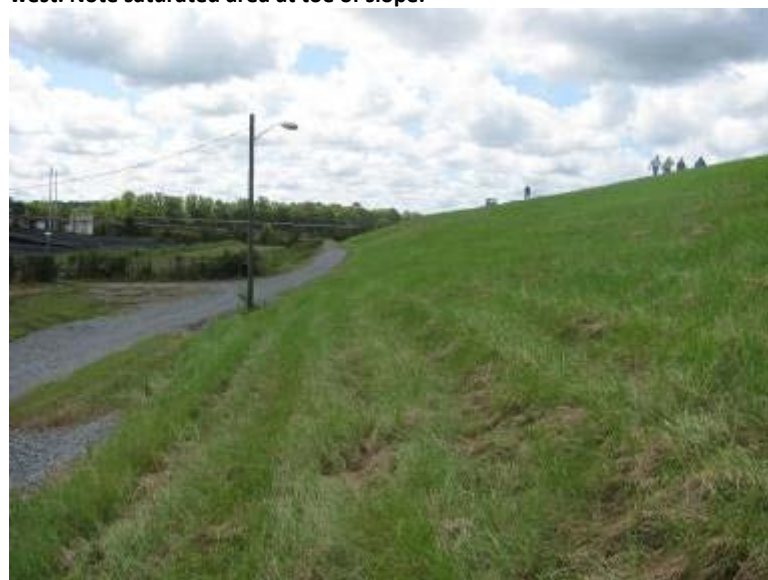
Photo 52: Upper East Pond – East embankment exterior slope, looking south.

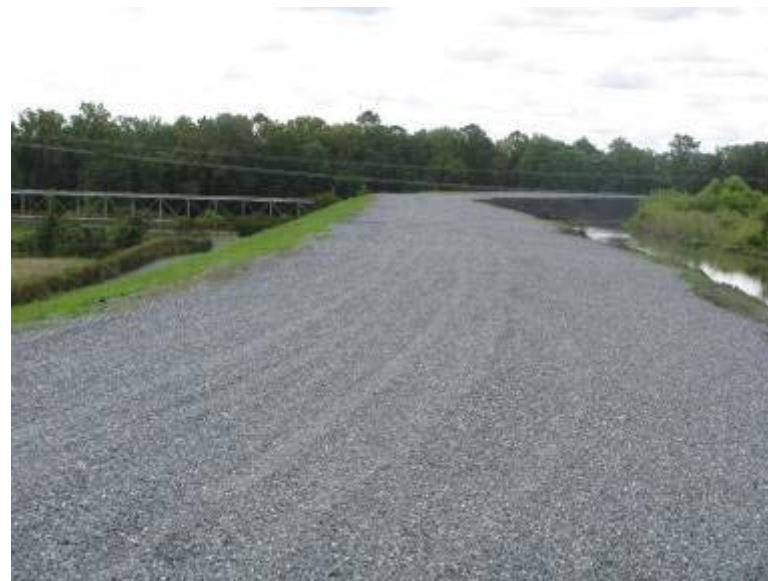
Photo 54: Upper East Pond – Crest of divider embankment, looking south.

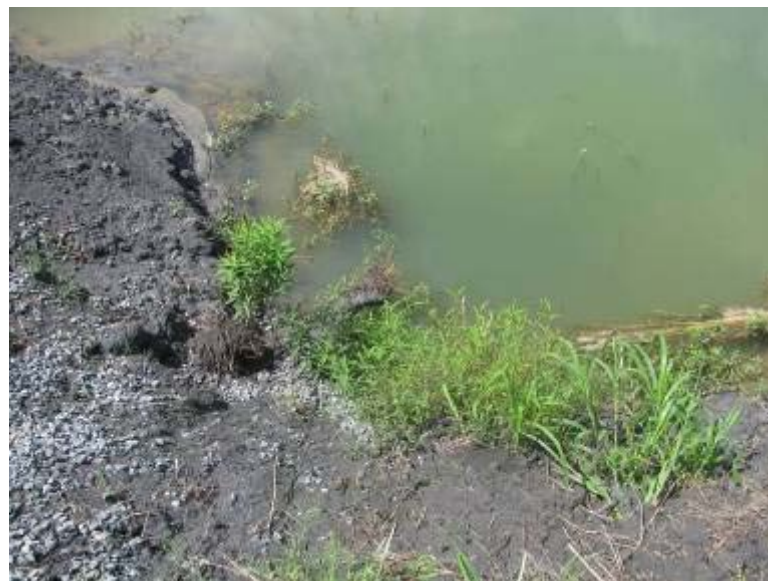
Photo 58: Upper East Pond – Divider embankment interior slope, Inflow pipe looking west. Note eroded areas at discharge of pipe.

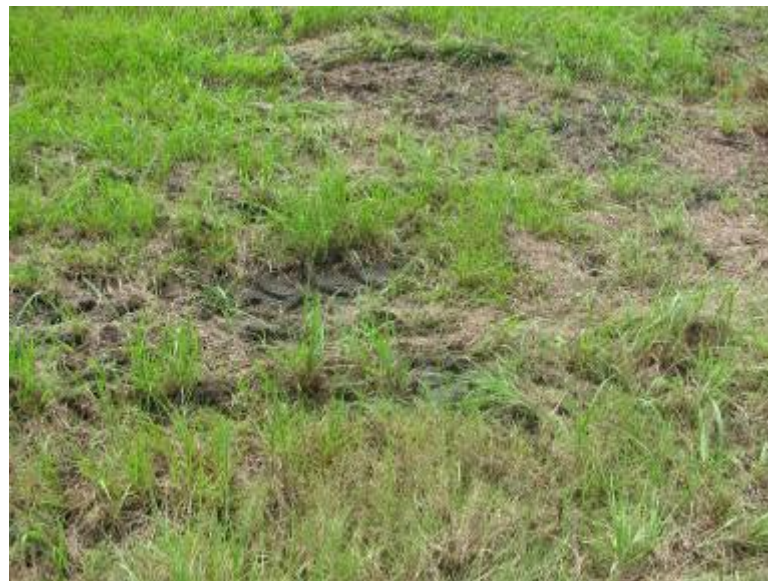
Photo 64: Upper East Pond – North embankment toe of exterior slope looking south. Note saturation at toe of slope.

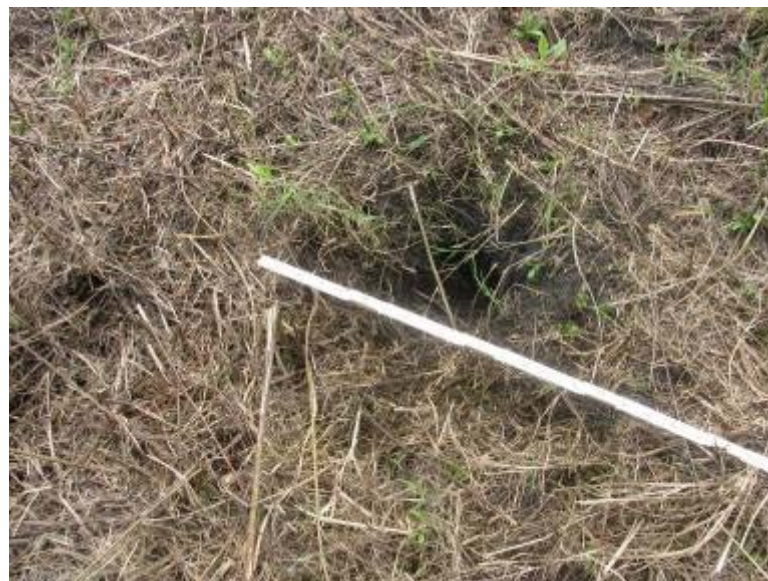
The repaired area, previously described in Section 3 of this report, located on the exterior slope of the north embankment was identified (Photographs 61 and 62). No signs of further seepage were observed in the area. An animal burrow was observed on the north embankment (Photograph 66).

Photo 66: Upper East Pond –North embankment mid-slope, Animal burrow. Note burrow is about 1-foot deep.

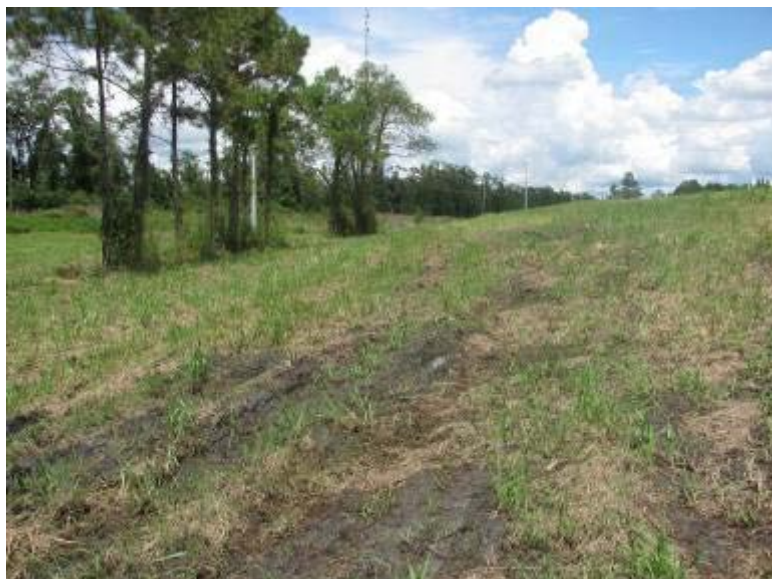
In general, the exterior slopes the Upper West Pond appear to be in good condition (Photographs 69 and 70). The embankment slopes are approximately 3H:1V with a flattening tendency towards the southwest corner of the embankment. Exterior slopes are covered with grassy vegetation about 4 to 6 inches tall. The alignment and slopes appear to be relatively uniform and consistent.

Photo 69: Upper West Pond – West embankment exterior slope, general view looking north.

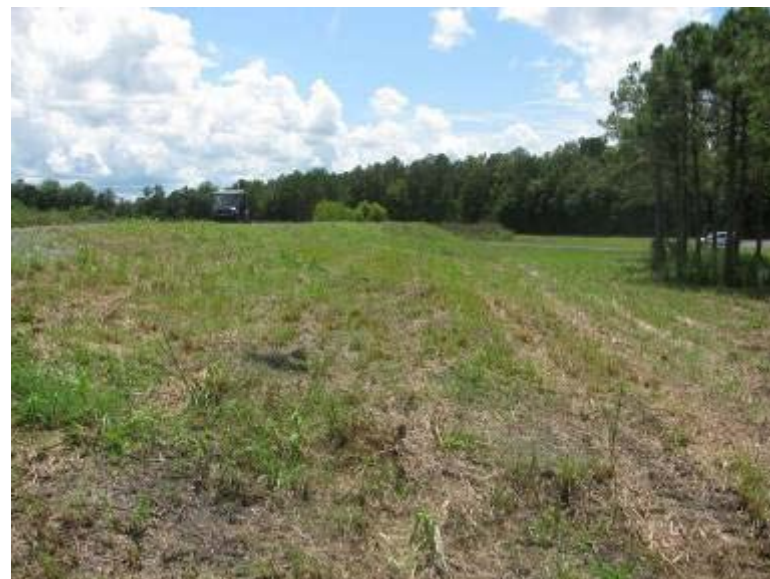
Photo 70: Upper West Pond – West embankment exterior slope, general view looking southwest.

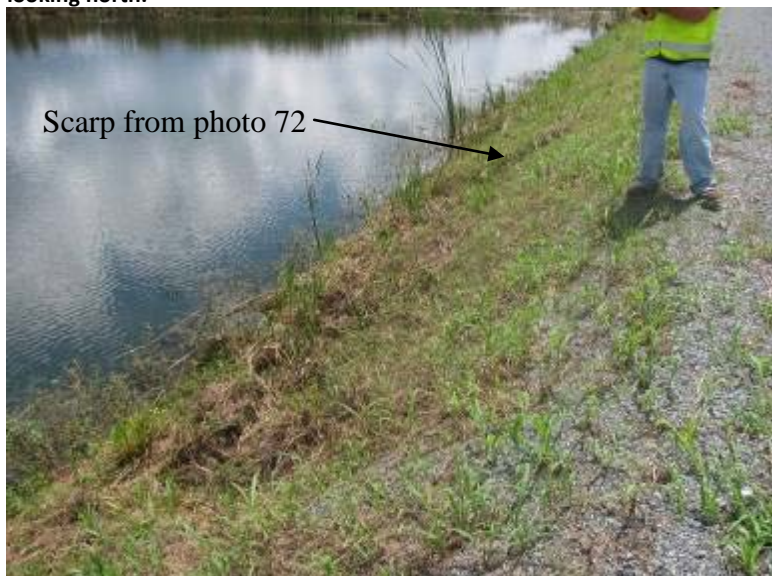
The interior slopes appear to be in fair condition. The interior slopes of the embankments were approximately 2H:1V. The interior slopes were generally covered with grassy vegetation approximately 3 to 6 inches tall. Shallow erosion and scarps were observed on the west interior slope (Photographs 71 and 72). An approximately 30-foot long erosion/depressed area (Photograph 73) was also observed at the west embankment. An 18-inch diameter corrugated HDPE inlet pipe is located near the southeast corner of the pond. Water was flowing thru the pipe from the Upper Middle Pond.

Photo 71: Upper West Pond – West embankment interior slope, general view looking south. Note shallow scarps over approximate 50-foot length.

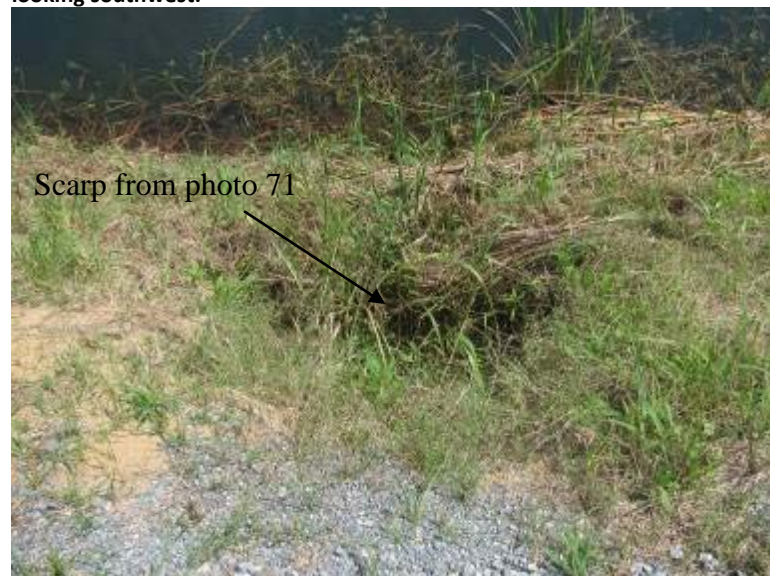
Photo 72: Upper West Pond – West embankment interior slope, scarp looking east.
